# **INHIBITED SHAPED CHARGE LAUNCHER TESTING OF SPACECRAFT SHIELD DESIGNS**

**Donald J. Grosch  
Southwest Research Institute**

**FINAL REPORT  
Contract No. NAS8-40634  
SwRI Project No. 06-7698**

**NATIONAL AERONAUTICS and SPACE ADMINISTRATION  
MARSHALL SPACE FLIGHT CENTER  
Huntsville, Alabama**

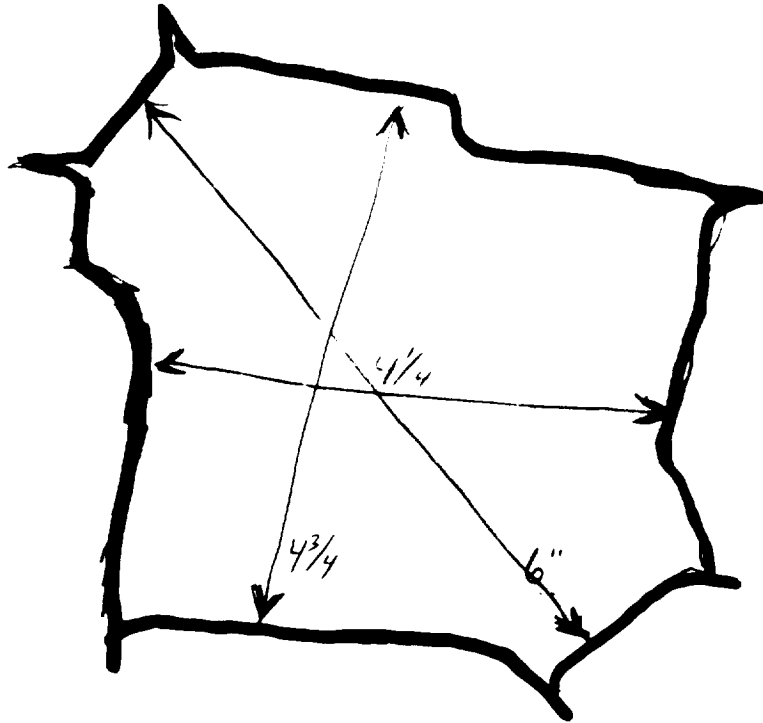
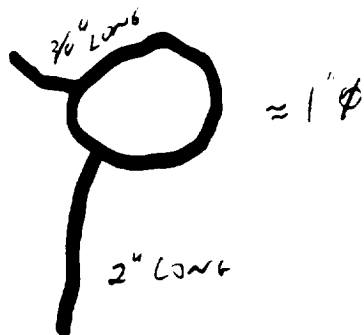
- # 1 - DESTROYED
- # 2 - HURT BAD
- # 3 - DAMAGED

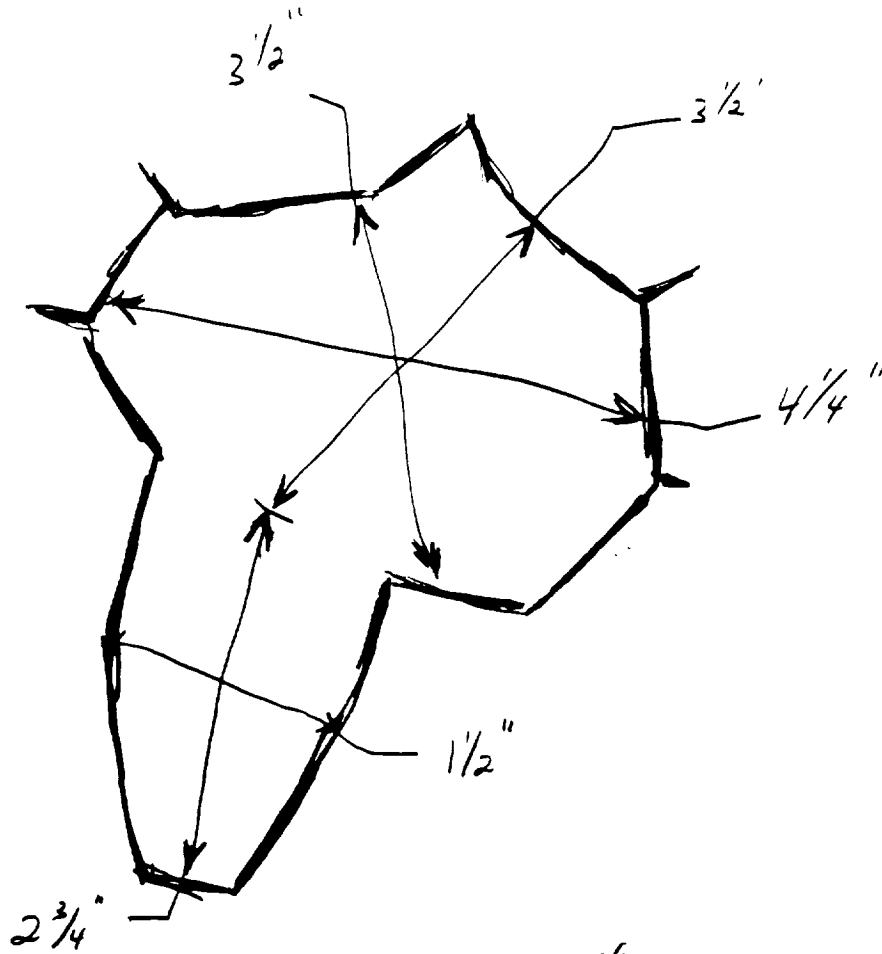
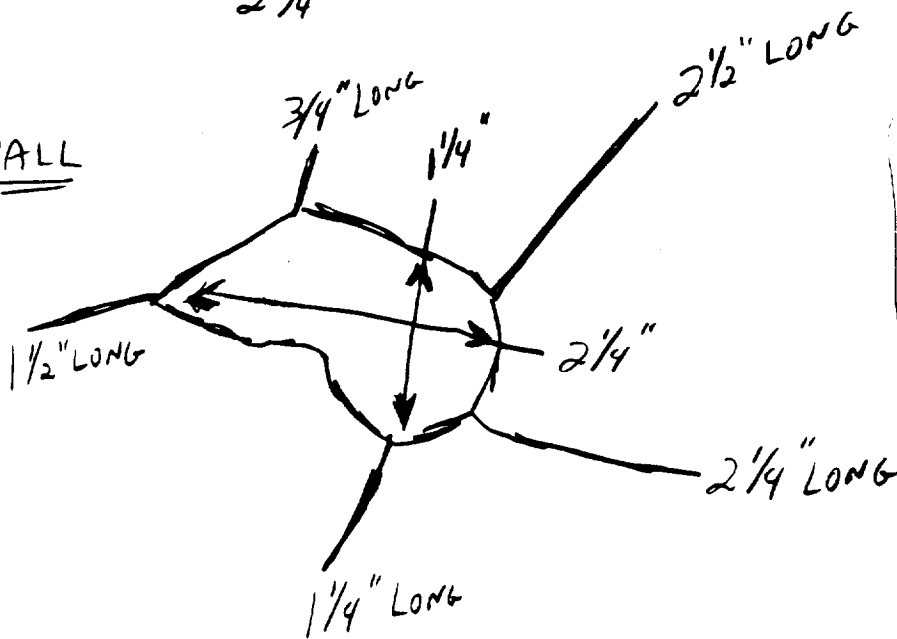
4"  $\phi$  Hole & A LOT  
OF TRASH

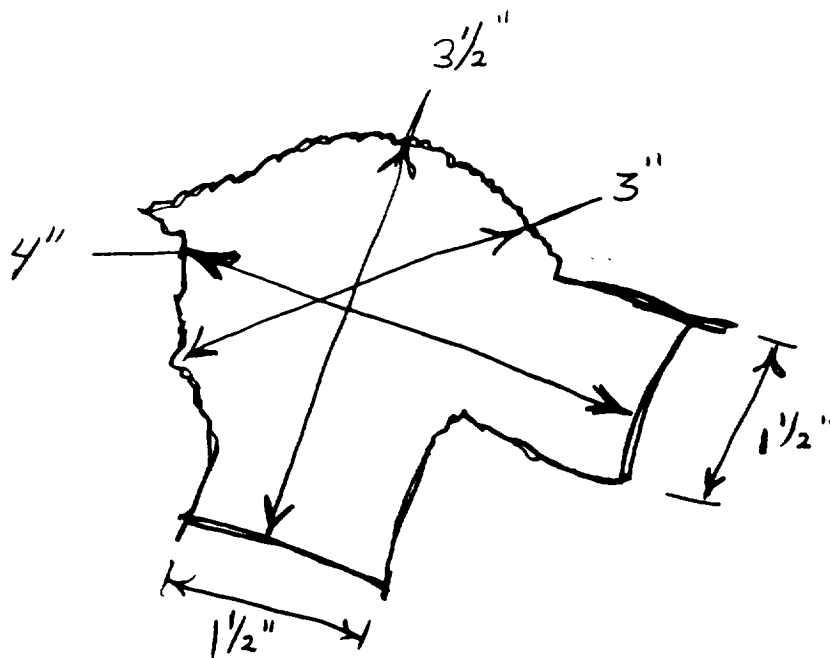
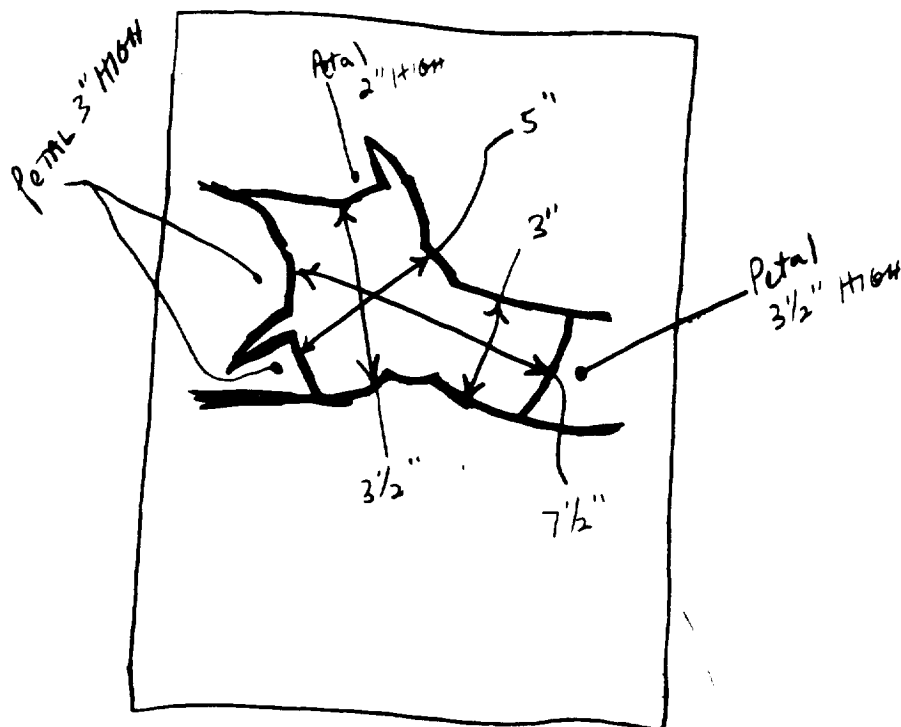
Had MULTIPLE  
SMALL TO MEDIUM  
(1/4"  $\phi$  TO 1"  $\phi$ )  
SIZE HOLES.  
All 3 were  
Deformed (Bent).

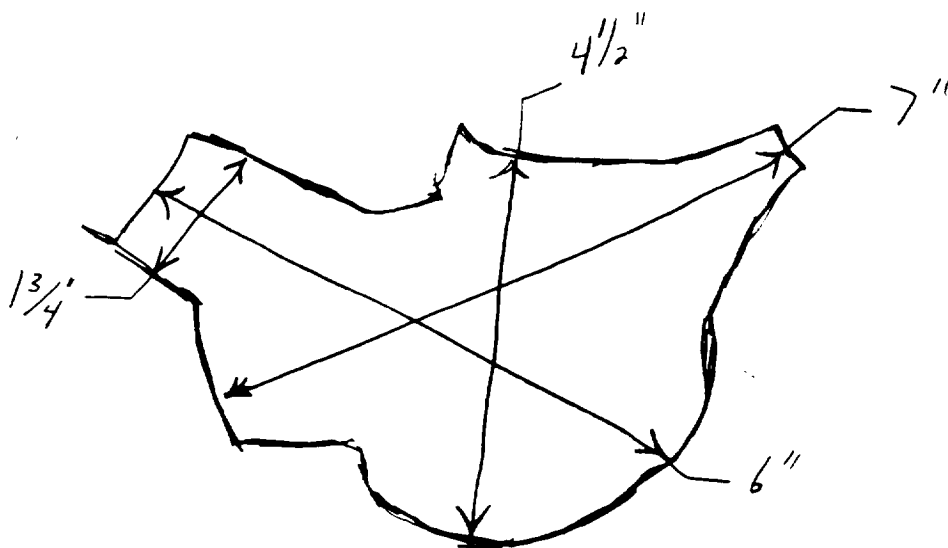
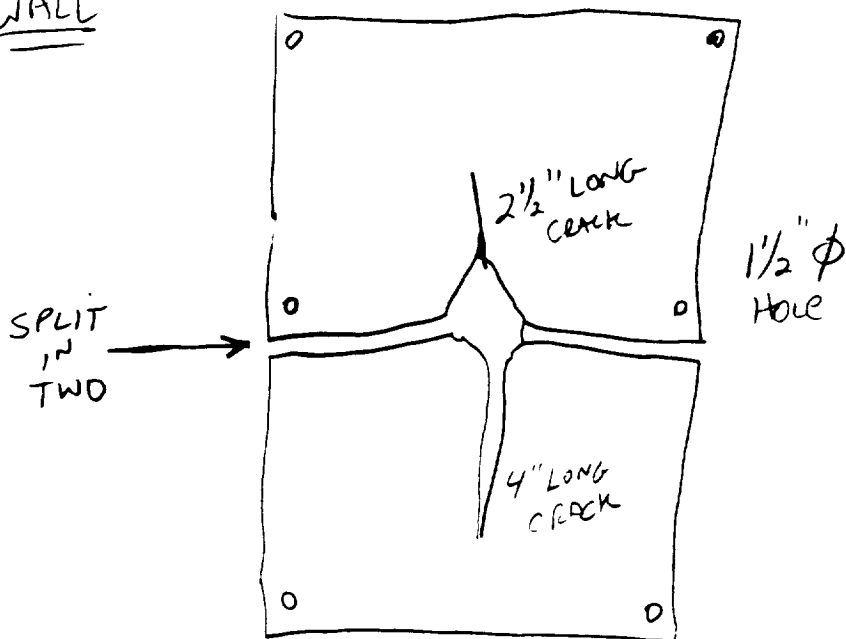
DAMAGE DECREASES FROM  
MANY SMALL ( $\frac{1}{2}$ ") HOLES  
ON PLATE #1 TO ONLY  
A FEW SMALL HOLES  
( $< \frac{1}{4}$ "  $\phi$ ) ON PLATE #2

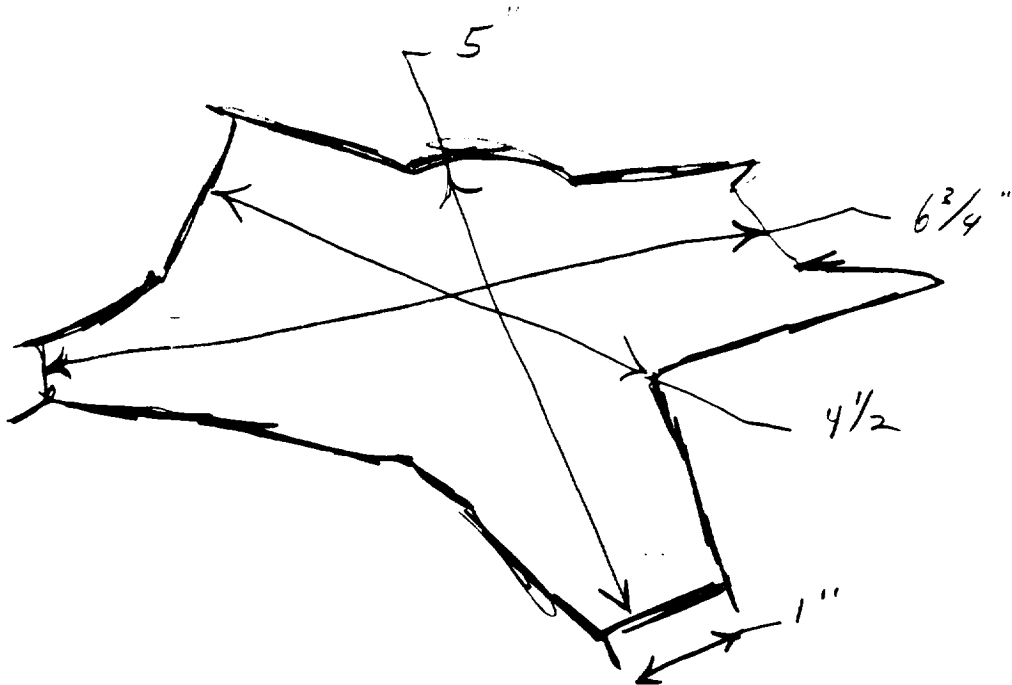
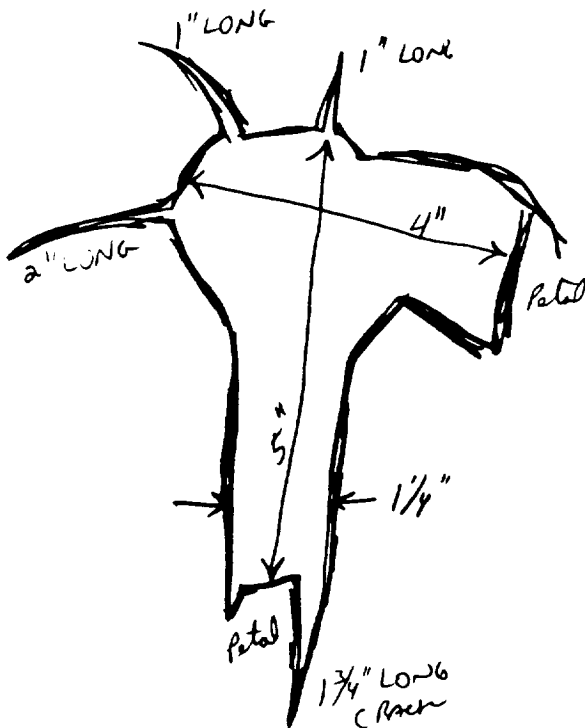
- #1 HAS A 8'  $\phi$  HOLE & LARGE BOND
- #2 IS CUT IN HALF WITH LARGE HOLE & BOND
- #3 HAS SEVERAL HOLES & A LARGE BOND

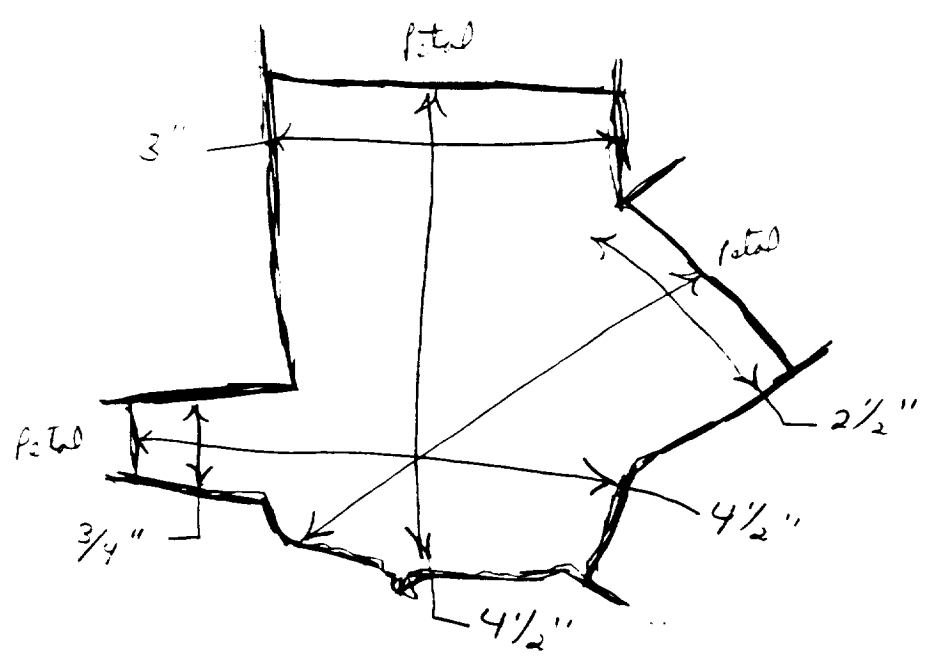
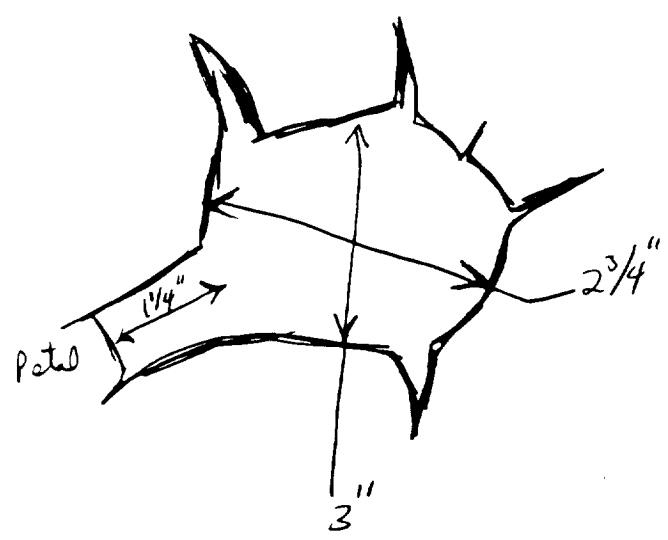
WITNESS Large wall in #1. Decreasing in #2. Several small ones in #3 (May have been removed, make screen visible)

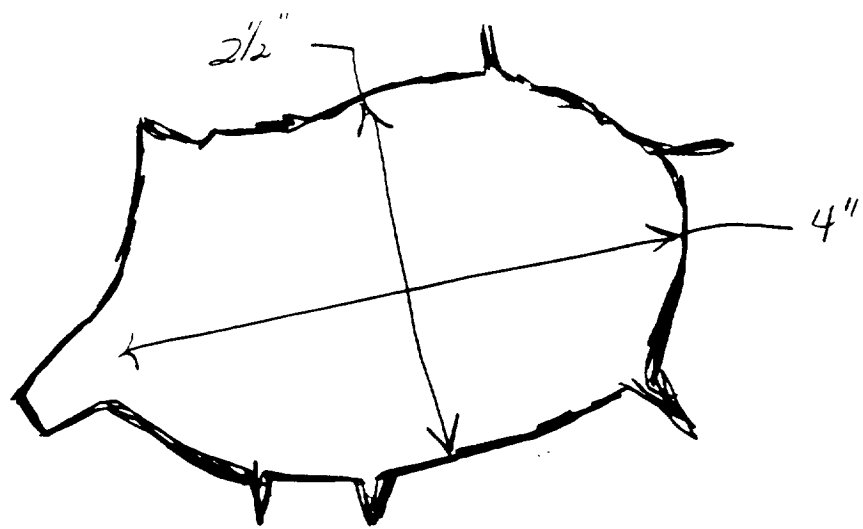
LE-15

Fabric Layers THROUGH Hole  $\approx 2"-3"$  Dia

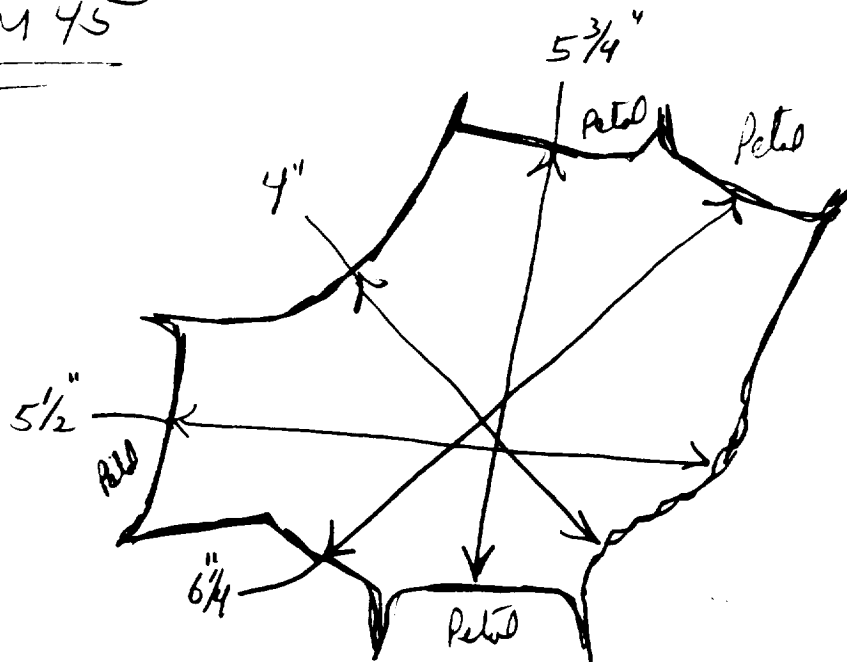
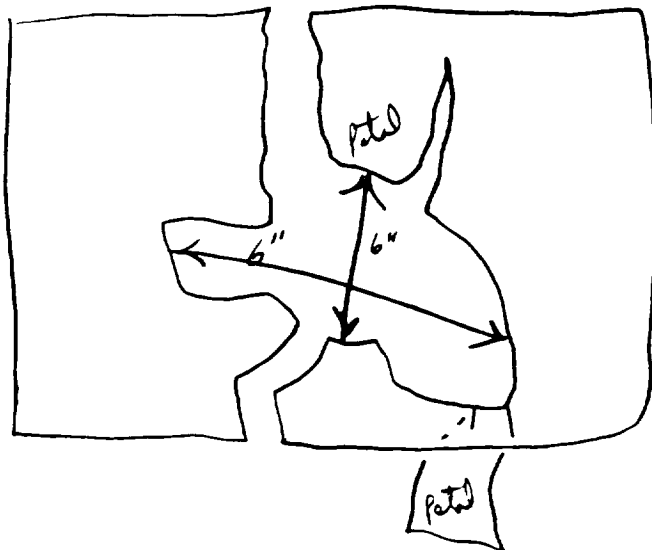
The projectile for Test 7698-9 produced a very jagged hole which resulted in large petal formation in the face plate. The diameter varied from 10.2 to 15.7 cm (4.0 to 6.2 inches). A large amount of damage was also done to the wall plate, which was broken in two pieces by the

impact. The approximate hole size of the wall plate was 15.2 cm (6 inches). A central hole was produced in all three witness plates. The damage decreases from many small holes in Witness Plate #1 to only a few small holes in Plate #3.

MULTIPLE small, 1 large (1 1/2" x 3/4") hole

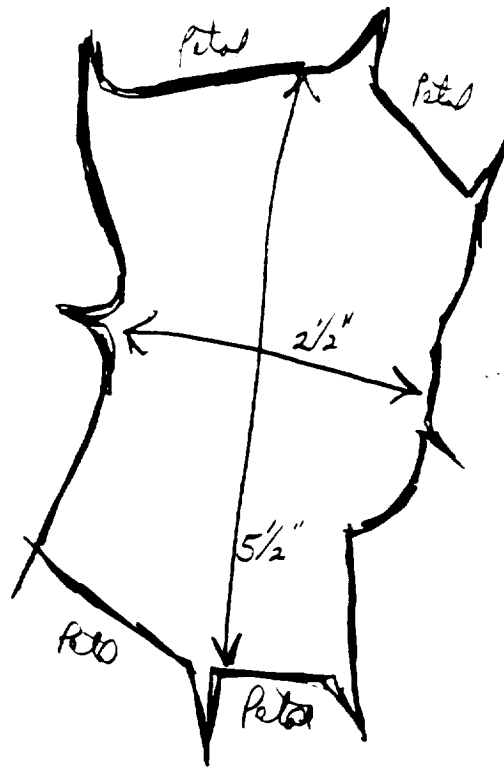
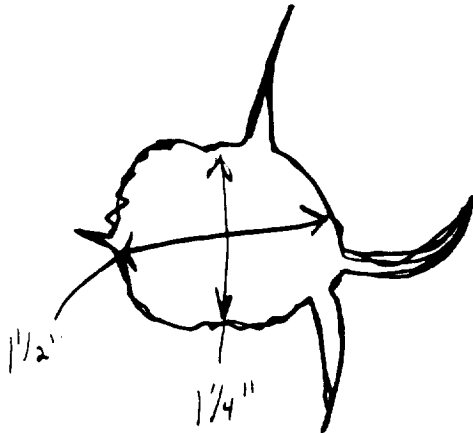
7098-10

Witness #1 4-5"  $\phi$  hole with multiple holes all over

#2 & #3 Hole pattern reduces to only small holes by shot  $\pi$

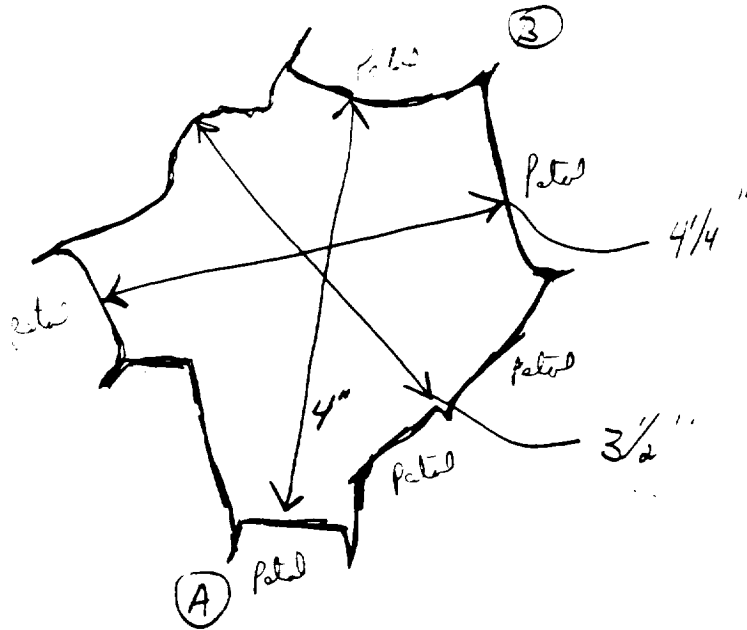
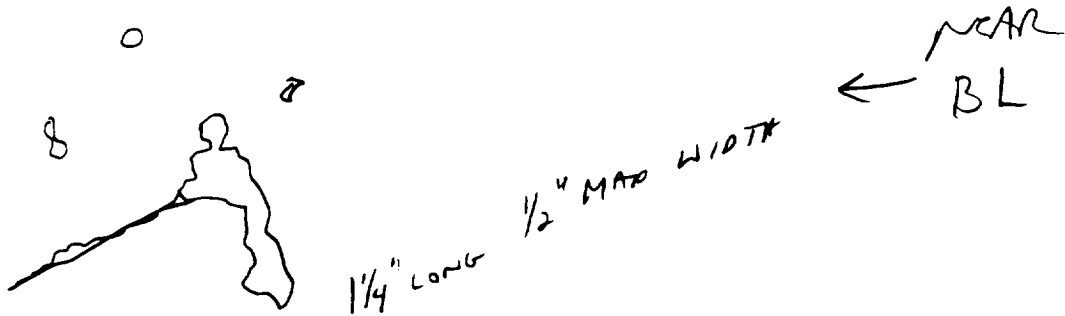
7075-11

Witness #1 Very Little Deformation  
Several Small Holes

#2 2 IMPACTS, NO PENETRATION

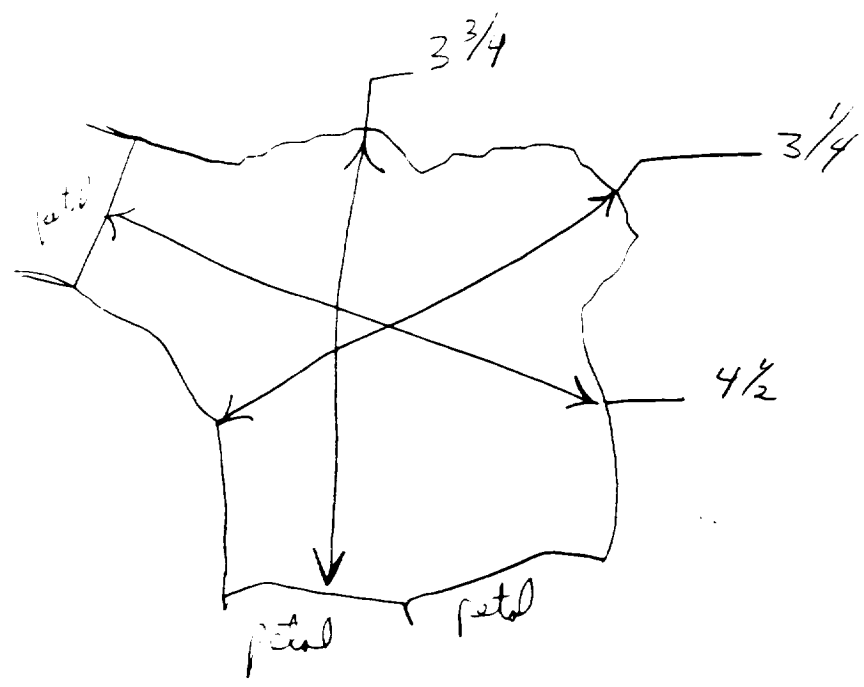
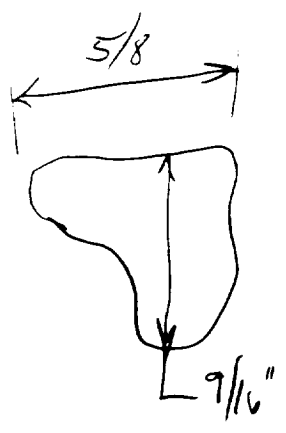
W1-nose - #1 HAS 2- 3/4" holes = 2 smaller holes  
 = 1- 1/4" hole = 1 hole 3/4" hole  
 = 2 holes

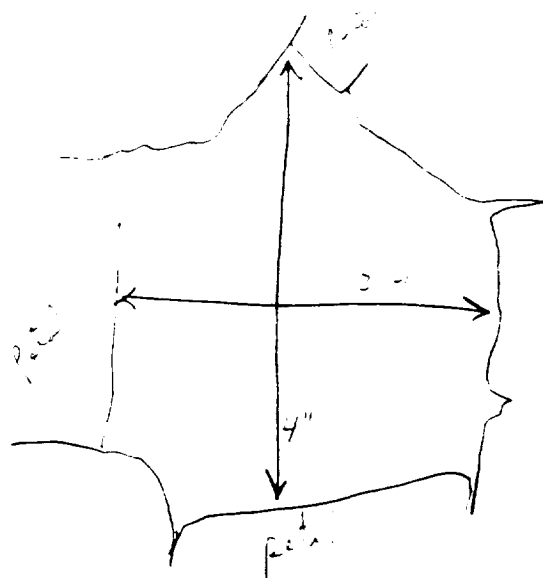
LE-5

WALL — NO PEN —  $\frac{3}{4}$  BULGE

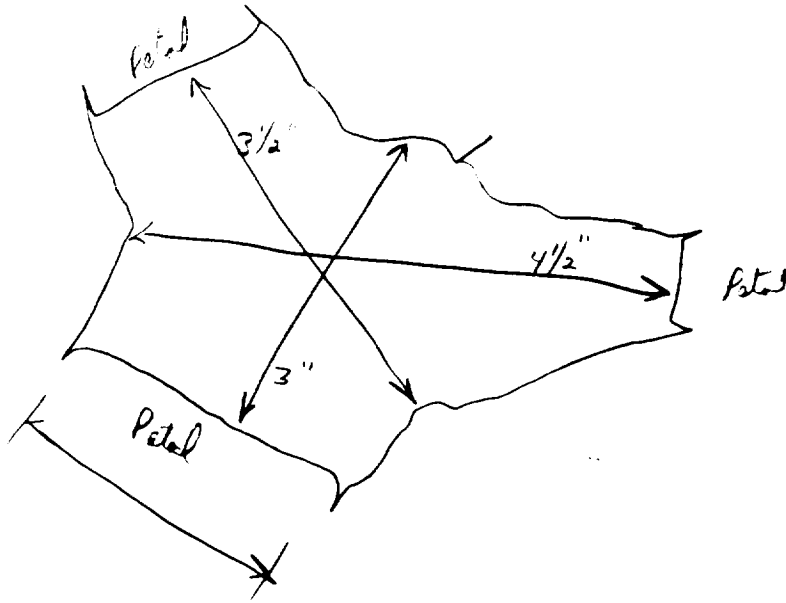
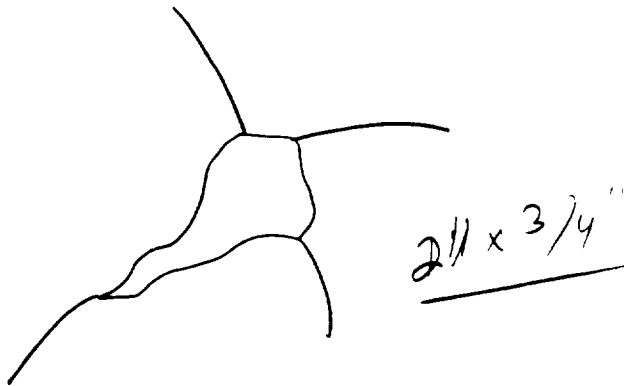
L45.8

Small Hub Pattern ( $\approx 100-150$ ) Decrease To  
A Few Dents & only 1 Hole is  $\#3$

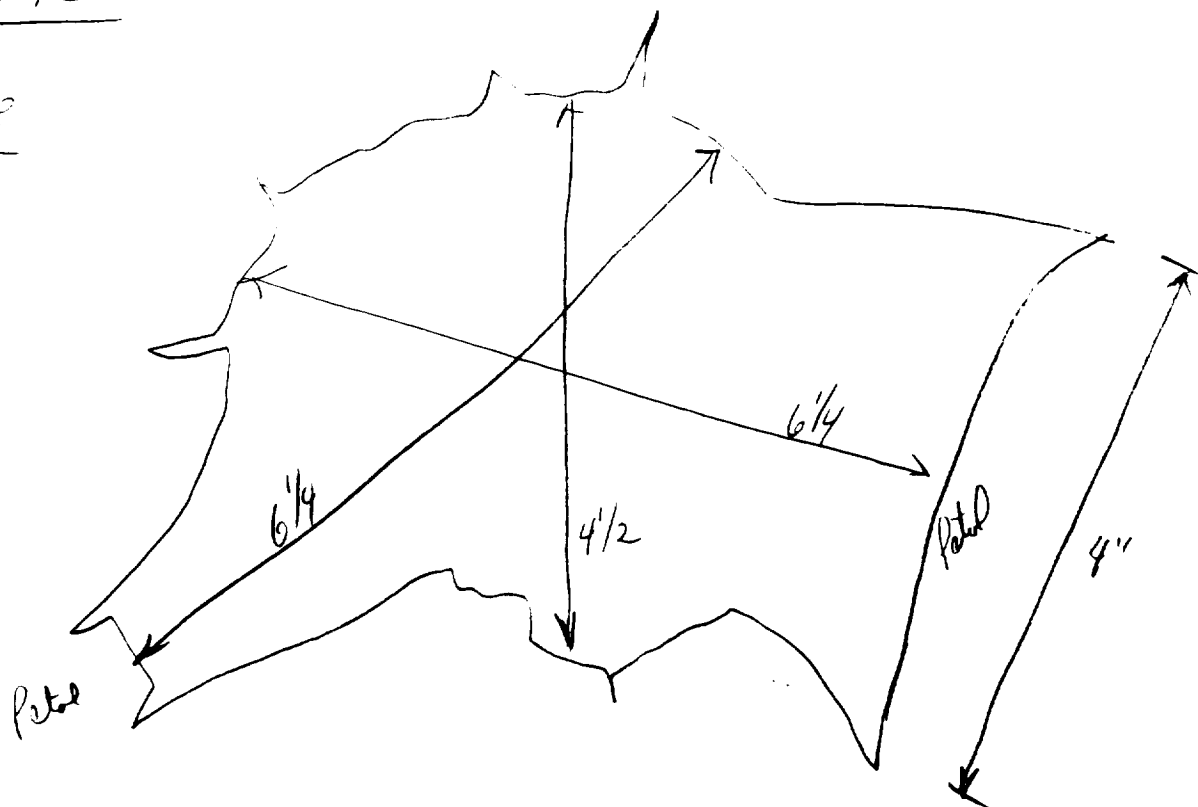
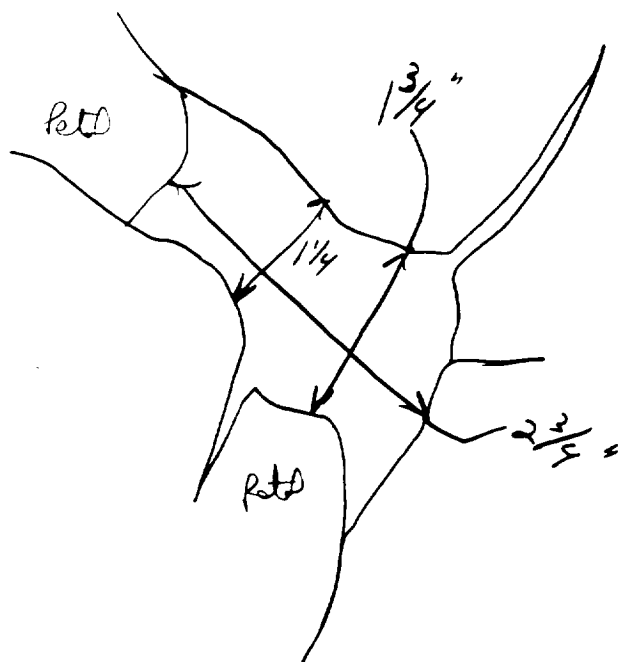
L45

Holes in #1 - (5 -  $\frac{1}{4}$  - 40 small -  $1\frac{1}{2}$  -

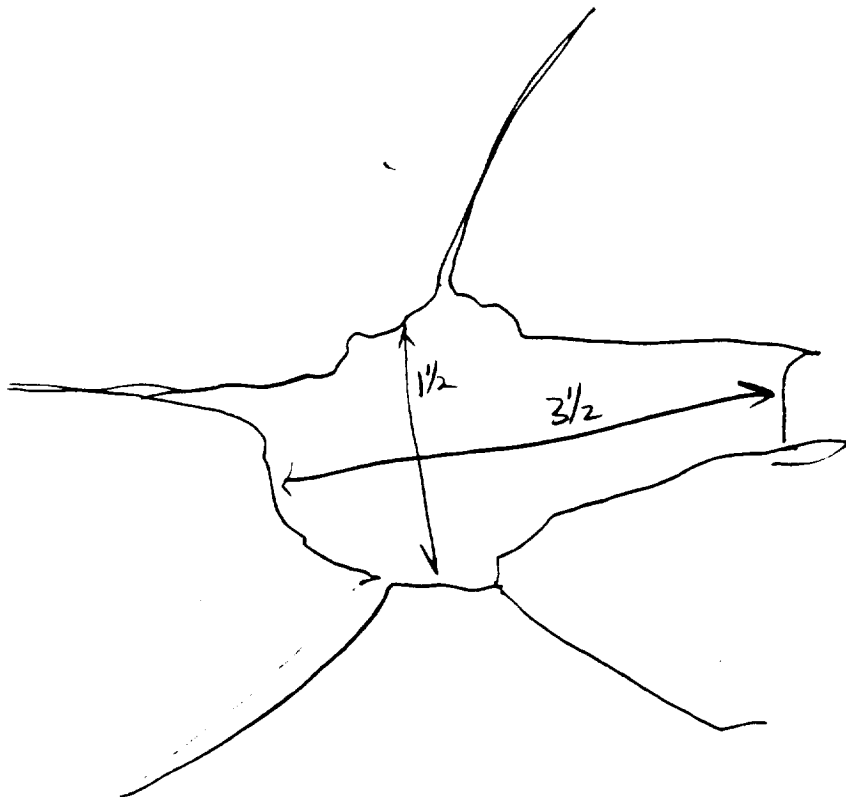
all 3 interior plates have numerous small holes

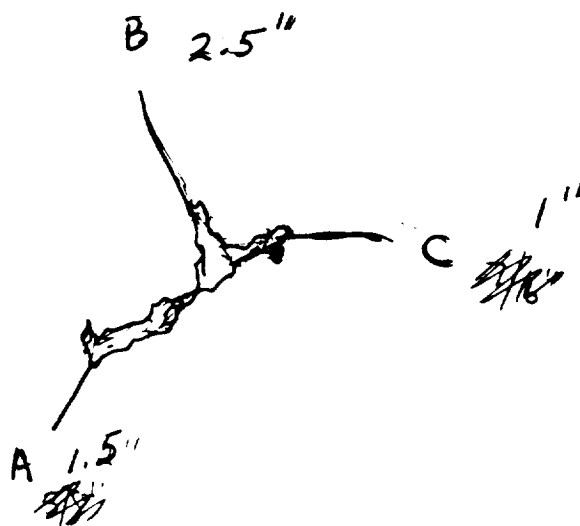
7698-11

LTT (A-B) -  $3\frac{1}{8}"$  (Airline Cracks)

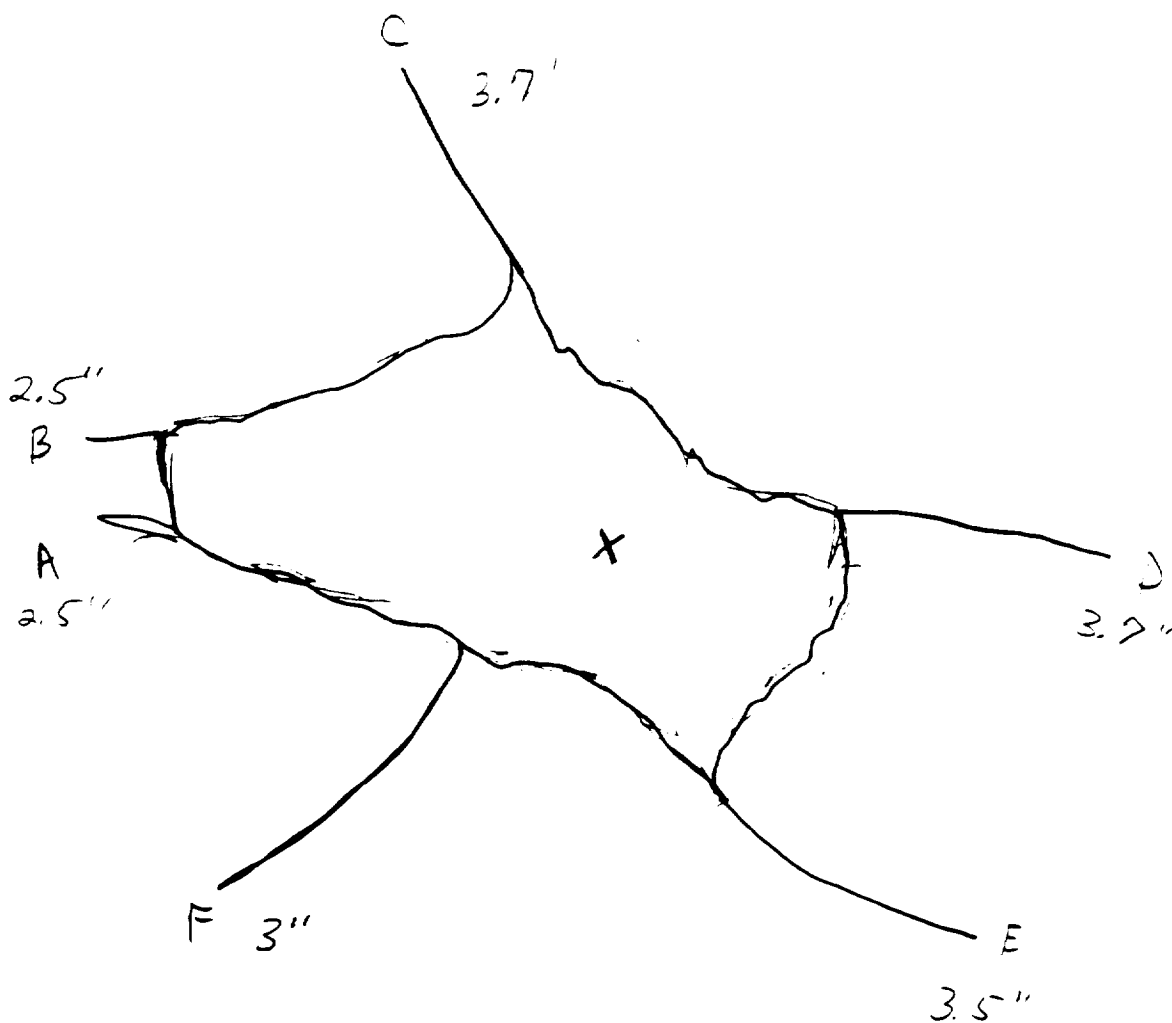
| TEST NO. | MASS (g) | VELOCITY (km/s) | TARGET | WALL DAMAGE (TIP-TO-TIP LENGTH) | COMMENTS |
|---|---|---|---|---|---|
| 7698-21 | - | - | LE0.8 | 1.5" to 3.5" Dia. Hole<br>(7") | Equipment Failure - No Pre-Impact Radiographs. Based on target, assume a fairly lethal projectile (high L/D, flying straight). |

$$\begin{aligned} CE &= 7 \\ DF &= 6\frac{3}{4} \\ BE &= 6 \\ AD &= 6\frac{1}{2} \\ BD &= 6\frac{1}{2} \end{aligned}$$
